DESCHUTES RIVER – BANK STABILIZATION PROJECTS ASSESSMENT

Prepared for:

River Design Group, Inc.
6029 SW 33rd Place
Portland, Oregon 97239

December 2005

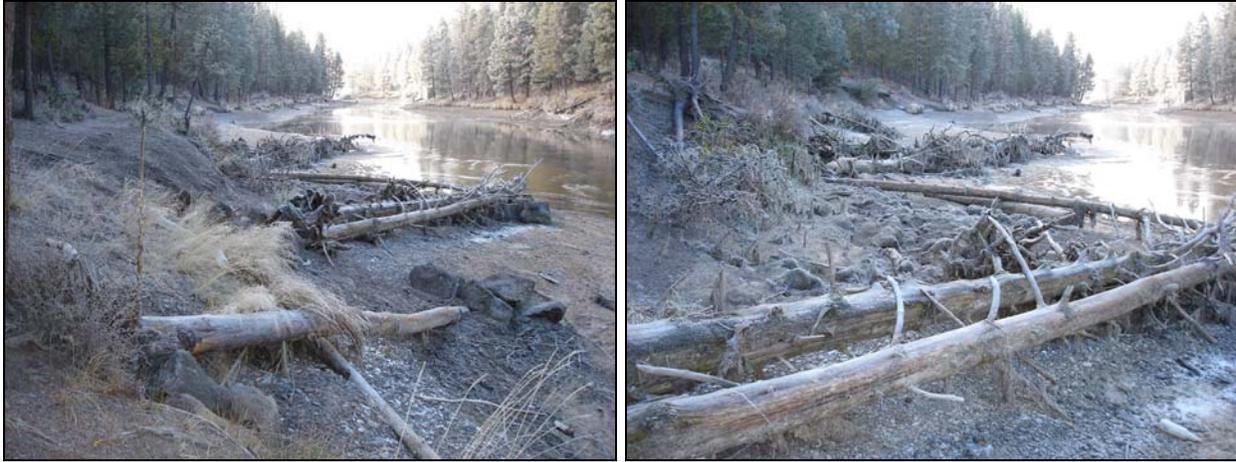
The large wood was placed singularly as well as in two triangular arrays (similar to a barb in plan view) intended to deflect flows away from the stream bank (Figure 4-1). Fill was placed inside of the triangular arrays and sedge mats were placed on the fill. Boulders were placed around the woody debris to anchor the material. Willow and spirea cuttings were placed at the toe of the re-graded slope.

Figure 4-1. Reach 1-1 site conditions looking upstream towards Wickiup Dam. The left photo shows the length of the project site. The right photo focuses on the triangular barb in the middle of the first photo. Note minimal sediment deposition and coarser gravels dominating the channel substrate.

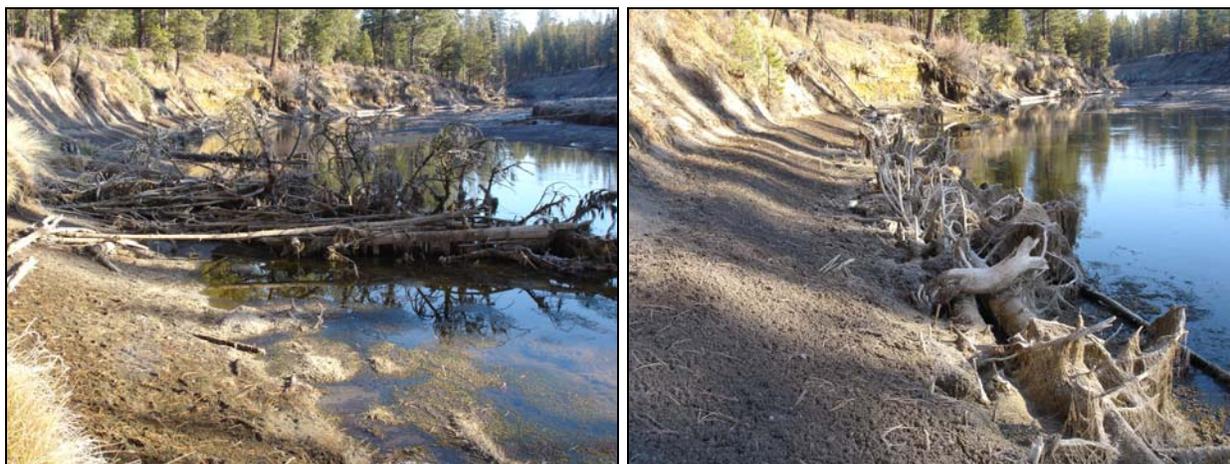
Figure 4-2. Reach 1-2 site conditions looking downstream from the top of the project. The large tree placed at the upstream extent of the project is collecting woody debris (left). Whole trees placed parallel to the bankfull bench provide resistance to scour although the sedge mats have been eroded from the bench.

The large wood project continues to function as intended. The leading whole tree is trapping smaller woody debris and provides bank protection. The additional whole trees continue to provide bench stability. Although channel cross-section survey data suggest the channel width has returned to the pre-project channel width, the stable bench would suggest the channel is narrower now than prior to the project. Similar to the Reach 1-1 project, fine sediment deposition in the project area was minimal. The re-graded terrace continues to erode through frost heaving and particle detachment. Frost heaving on the bankfull bench also destabilizes soil in the project area.

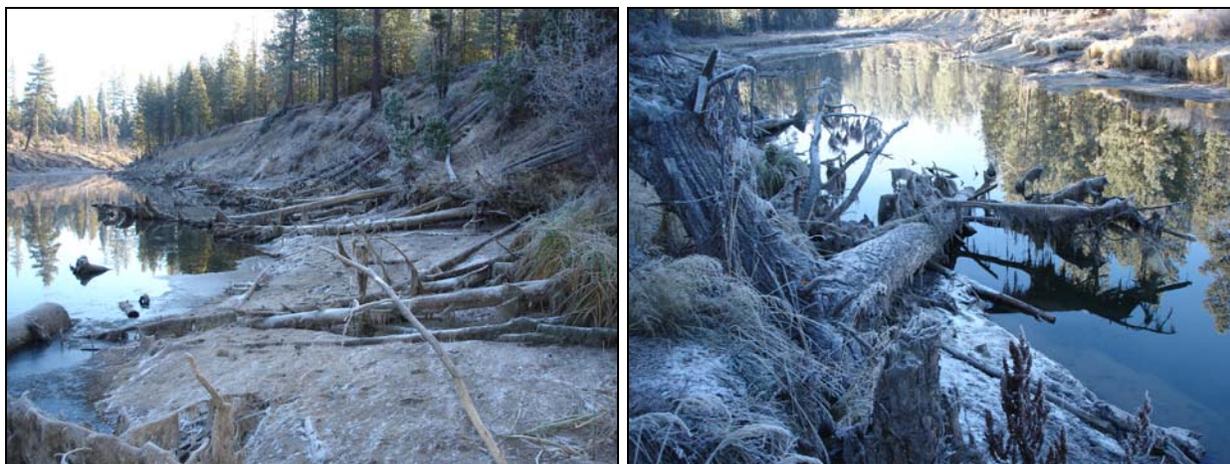
Figure 4-3. Reach 1-3 site conditions. Large wood was placed perpendicular to flow and interacts with the low flow channel (left). Whole trees provide aquatic habitat during low flows (right).

This project is meeting the project goals of reducing terrace erosion, improving riparian vegetation condition, and enhancing aquatic habitat. The bankfull bench is stable and vegetated by sedge mats and willow cuttings. Placed wood interacts with the low flow channel and provides bank stability.

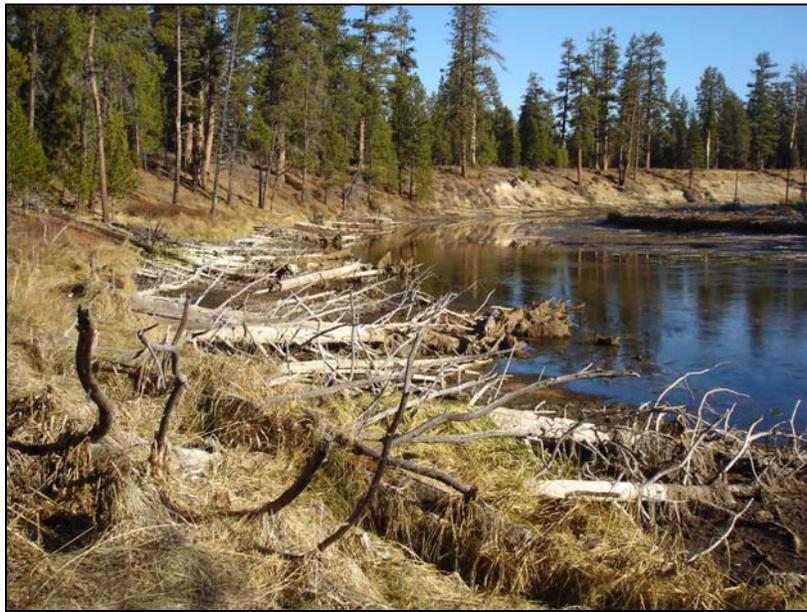
Figure 4-4. Reach 2 site conditions are characterized by large wood perpendicular to the channel on the outside of a channel meander. Woody debris at this site appears to have been placed.

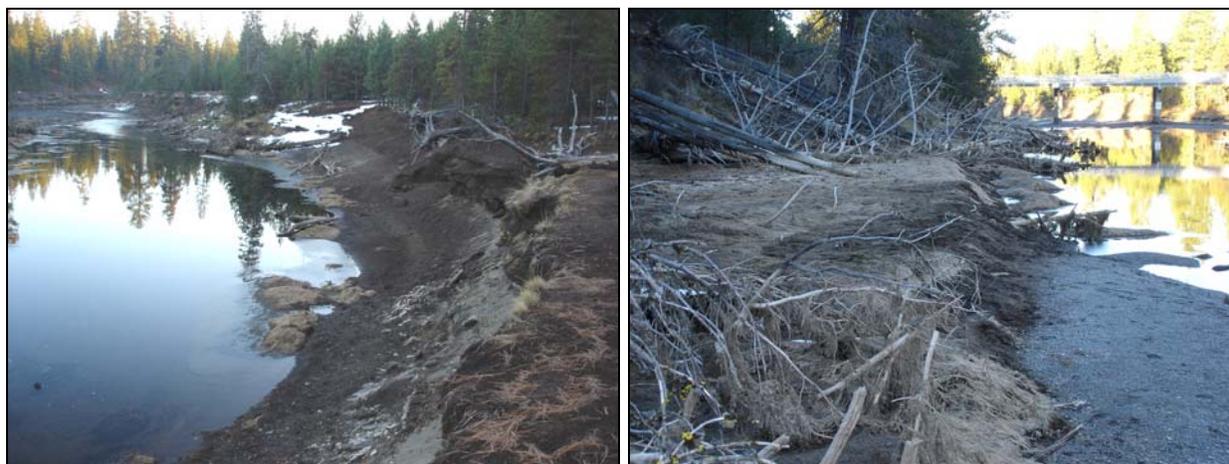
Figure 4-5. Varied channel conditions in the La Pine State Park reach. High terraces are actively eroding and infrequent woody debris accumulations lead to poor aquatic habitat and riparian vegetation (left). Stable straight reaches support vegetated floodplain surfaces and stable large wood (right).

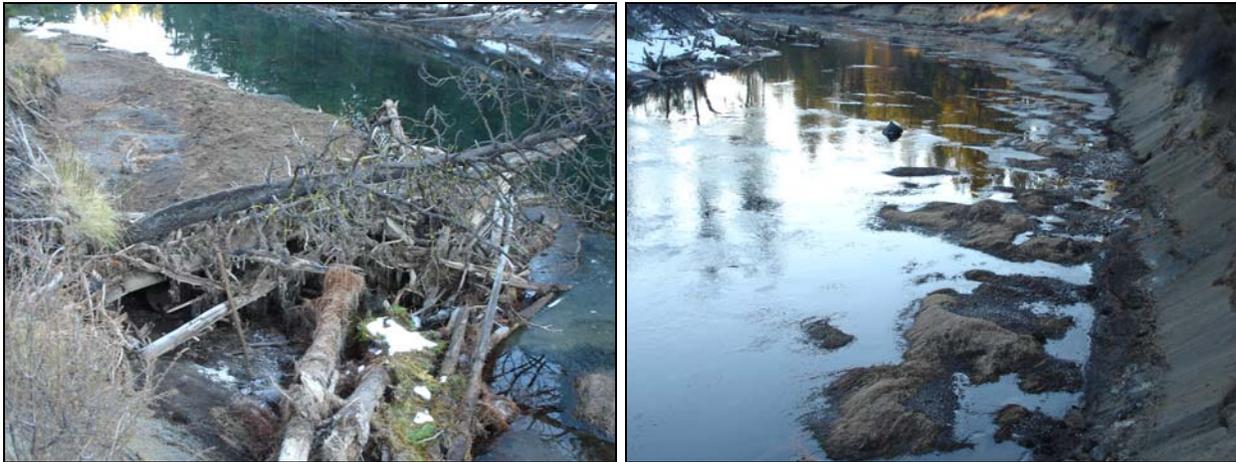
Figure 4-6. A substantial woody debris jam influences sediment deposition and provides fish habitat (left). The channel upstream from the jam is over-widened and has simplified low flow aquatic habitat (right).

Woody debris jams appear to have the greatest influence on channel morphology, sediment deposition, and aquatic habitat. Compared to individual pieces of wood, jams are more stable and will continue to grow in size over time as they collect more material and wood is anchored by accumulating sediment. As a jam’s volume increases, so will the jam’s interaction with the channel. Figure 4-7 shows two other jams observed in the La Pine State Park reach. These jams are formed by aggregated trees that were likely individually placed in the upstream channel. The

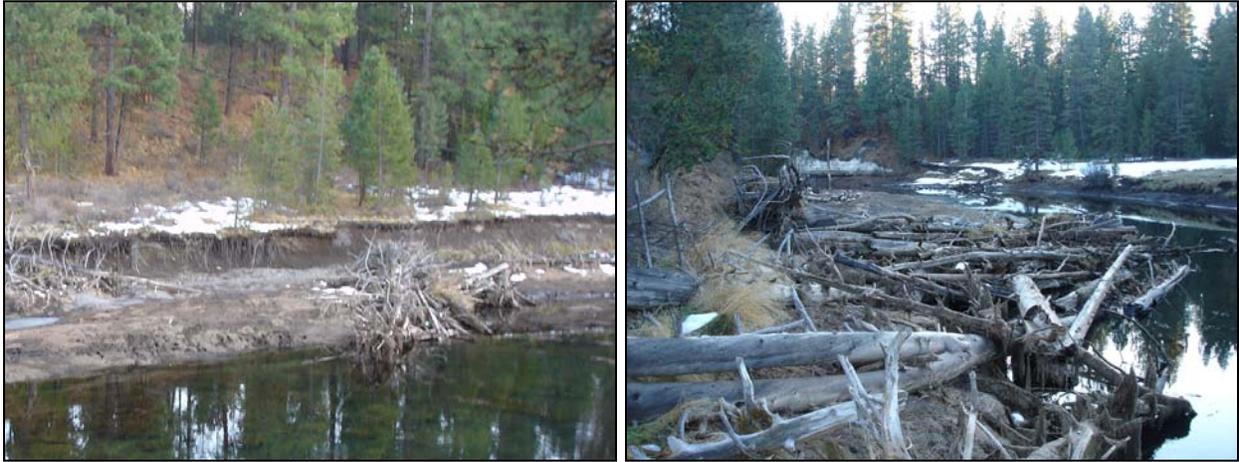
Figure 4-7. The role of woody debris jams in affecting fine sediment deposition (left) and capture of large woody debris along channel margins (right).

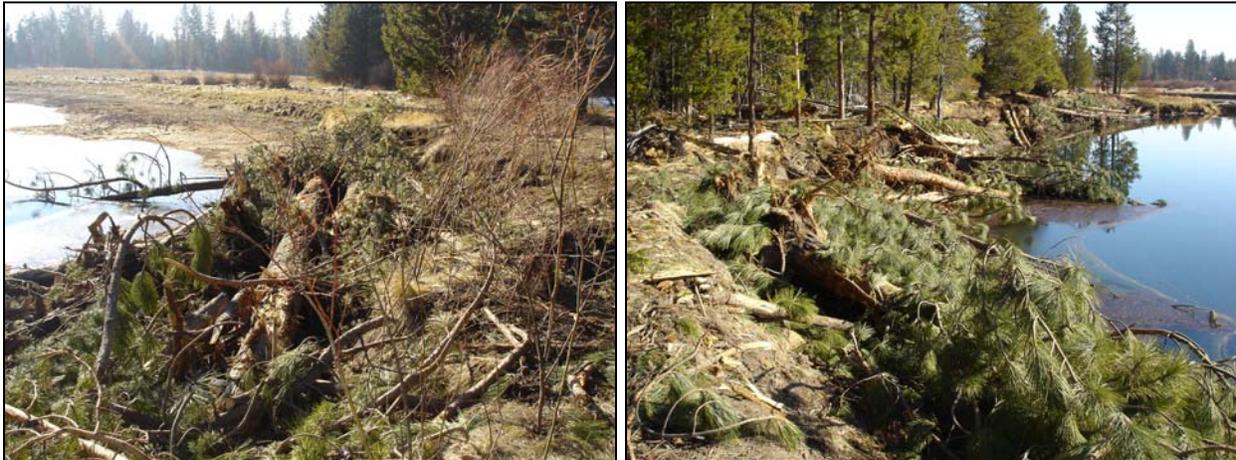
Figure 4-8. A view of the upstream end of the project shows the well-vegetated floodplain in the distance and treated bank in the foreground (left). The lower half of the project showing large wood placed on the re-graded terrace (right).

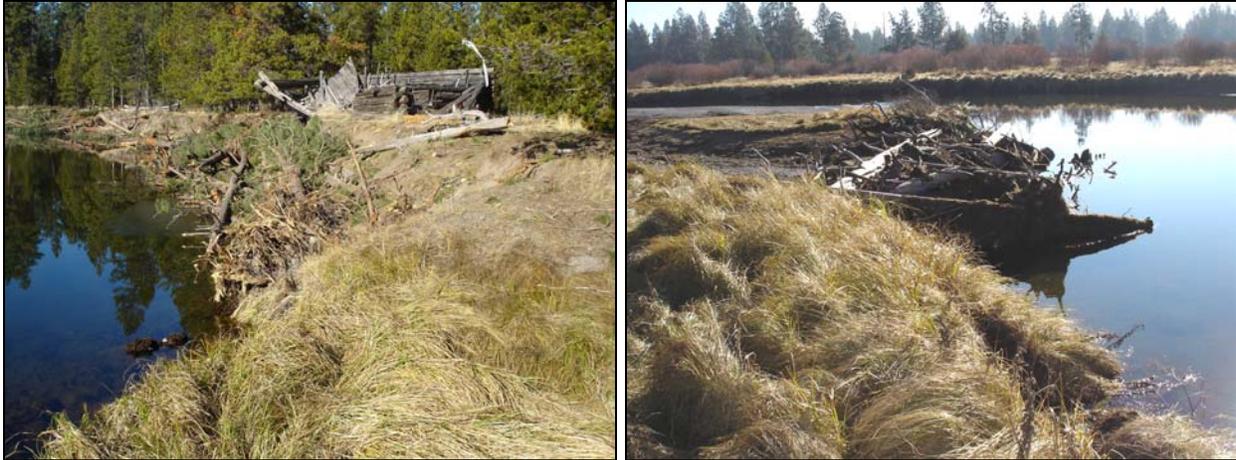
Figure 4-9. A view of the downstream end of the project showing the old cabin and the transition from the terrace to the vegetated floodplain (left). Downstream of the project area, a debris jam has formed at the mouth of a short avulsion channel (right). A willow/sedge community characterizes floodplain vegetation in the distance.

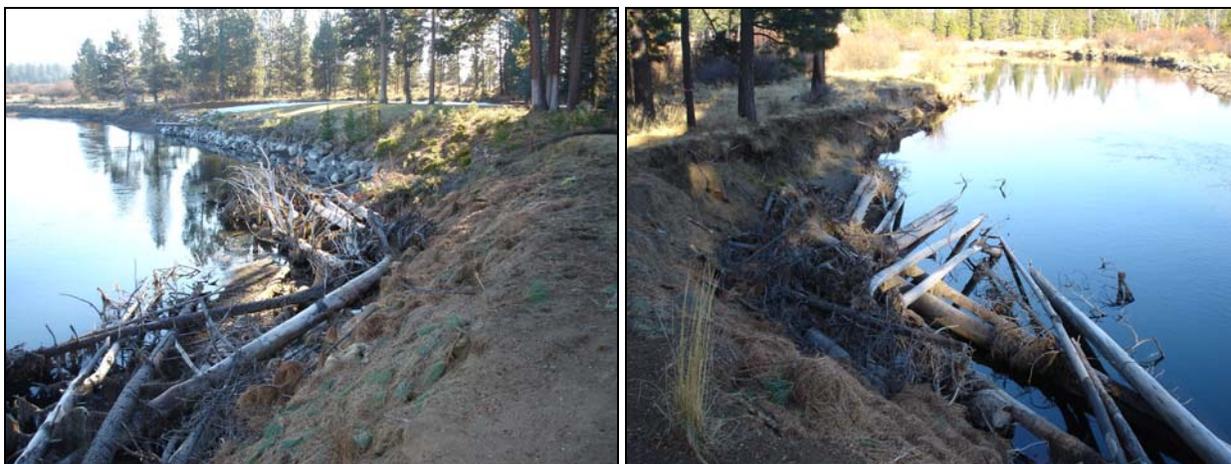
Figure 4-10. A view of the upstream end of the project shows the upstream property’s riprap bank and the large wood placed in the upper end of the Rotz project (left). The lower half of the project has created over hanging cover for fish. Terrace erosion appears to be continuing downstream of the project (right).

The structure appears to be stable based on the large amount of wood remaining in the structure. However, as was discussed in the Old Cabin site description, a bankfull bench was not constructed adjacent to the eroding terrace. This may result in future terrace erosion once the woody debris has degraded. Erosion appears to be taking place downstream of the project until the terraces grades into the floodplain where the pool transitions to the riffle. The vegetation condition on the re-graded terrace face remains poor. Promoting vegetation growth on the terrace would improve the site’s long-term stability.

The Rotz project remains stable although the long-term success of the project is questionable due to the poor riparian condition. The whole trees placed in the channel and along the bank are buffering the terrace from erosion and providing diverse aquatic habitat. Cabling the trees together has retained the large wood on-site and reduces the possibility of future tree loss.

In summary, the Rotz project has improved aquatic habitat and reduced terrace erosion. Relative to the upstream riprap bank, the placed wood is more natural in appearance and likely offers better habitat. Planting vegetation on the terrace face is recommended.

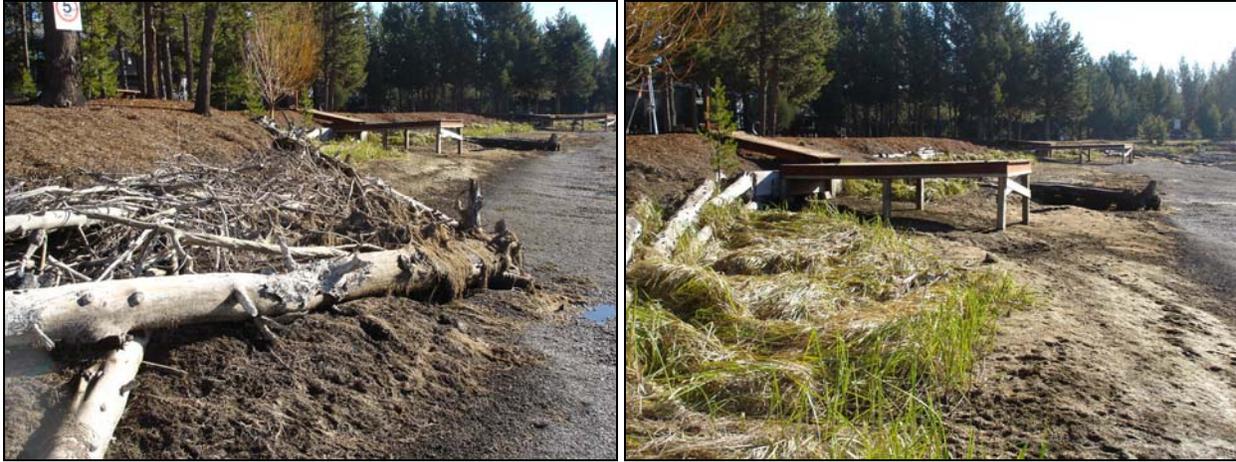
On the Oldham property (located downstream from Moreland) whole trees were placed in the channel and filled with small woody debris and soil (Figure 4-11). Although the downstream barb does not appear to have been planted, the upstream barb and other portions of the channel were planted with sedges harvested from the across-river floodplain. The terrace was re-graded and trees were placed in the bank to improve bank resistance to scour. Mulch was placed over the trees and willows have been planted along the lower terrace slope. Sedges placed at the appropriate elevation have survived and colonized other areas of the channel margin.

Figure 4-11. A view of the upstream triangular barb filled with small wood and soil (left). Sedges planted at the appropriate elevation have spread along the channel margin and improved soil stability (right).

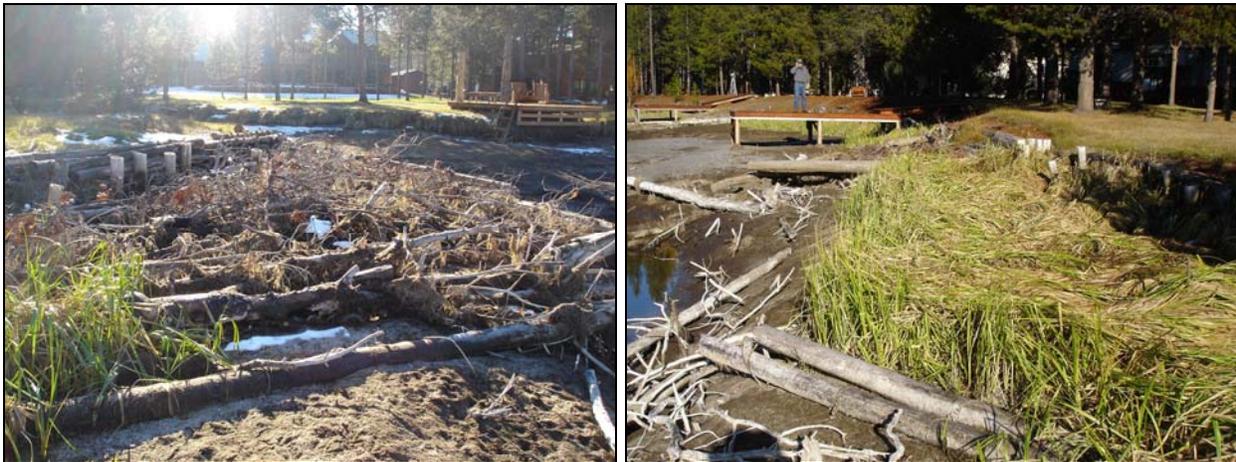
Figure 4-12. The upstream barb has captured sediment and provides bank stability (left). Sedges planted at the appropriate elevation have prospered and colonized onto the deposited sediment trapped downstream of the barb.

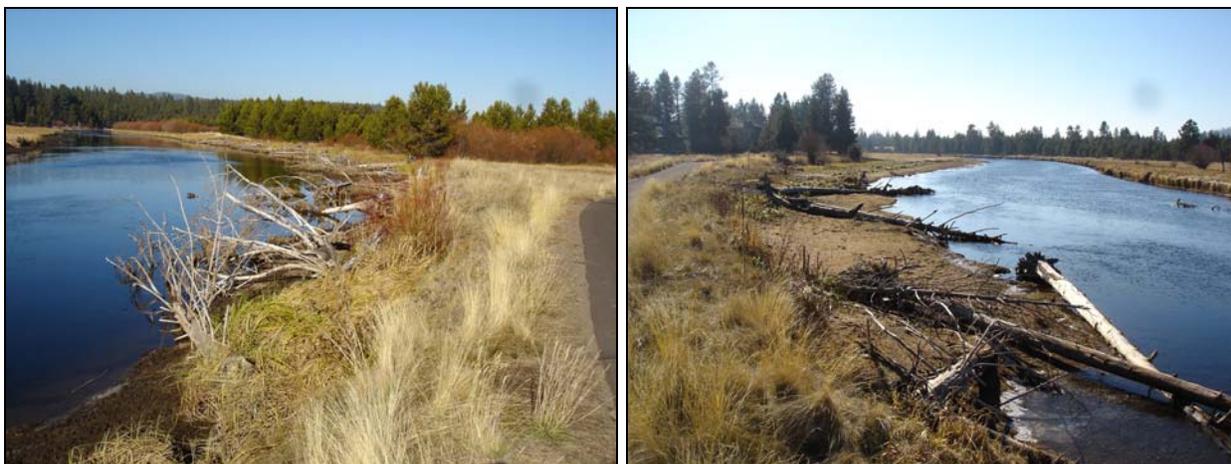
Figure 4-13. The Sunriver Airport site is characterized by whole trees extending into the channel (left). The upstream half of the project has more recent sediment deposition and a lower riparian vegetation condition (right).

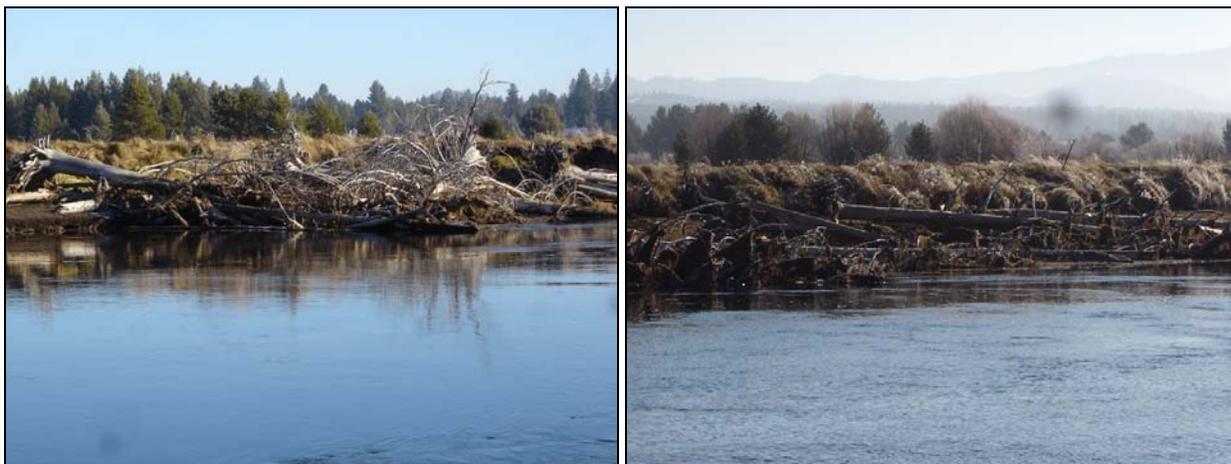
Figure 4-14. The upstream Sunriver Marina site was stabilized with large wood (left). The bank does not appear to have been sloped prior to wood placement and continues to erode (right).

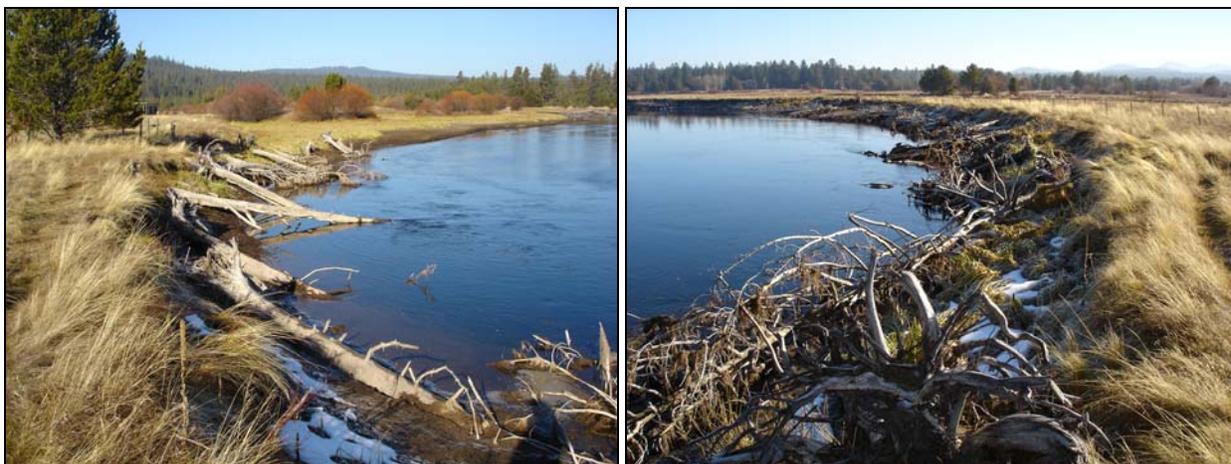
Figure 4-15. The downstream Sunriver Marina site begins at the transition from the floodplain to a higher terrace (left). Individual whole trees were placed in the channel at varying angles to the bank (right).

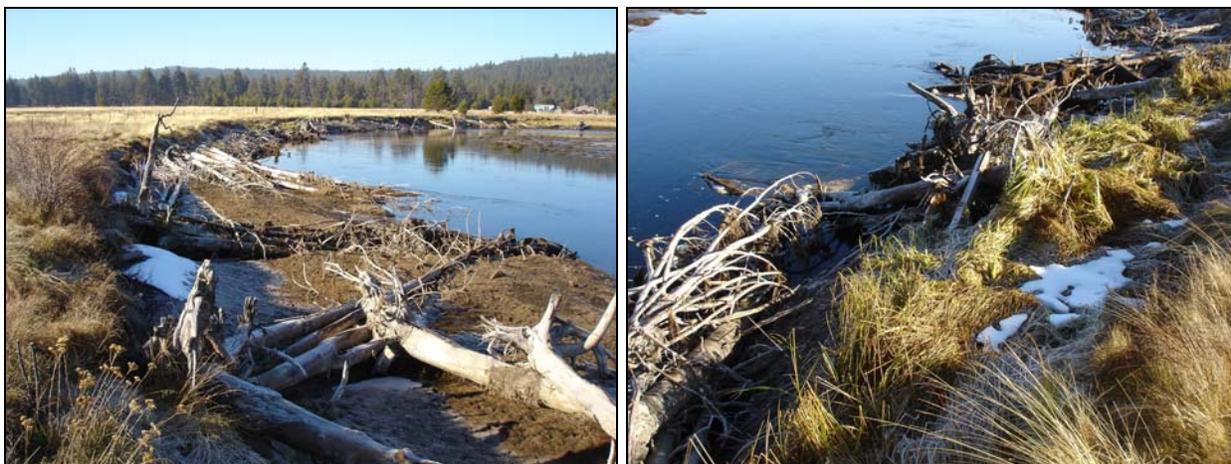
Figure 4-16. Sediment storage in the vicinity of placed trees (left). Sedges have colonized deposited sediment at the toe of the sloped low terrace (right). Successful willow cuttings are located near the top of the low terrace bank.
