Upper Deschutes Subbasin Assessment August 2003

EXECUTIVE SUMMARY

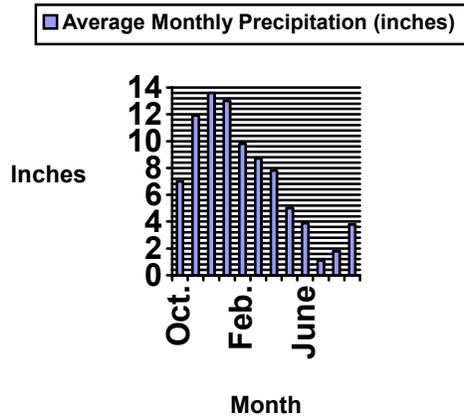
Figure 1: High Elevation Precipitation in the Cascade Subalpine/ Alpine and Cascade Crest Montane Forest Ecoregions of the Upper Deschutes Subbasin

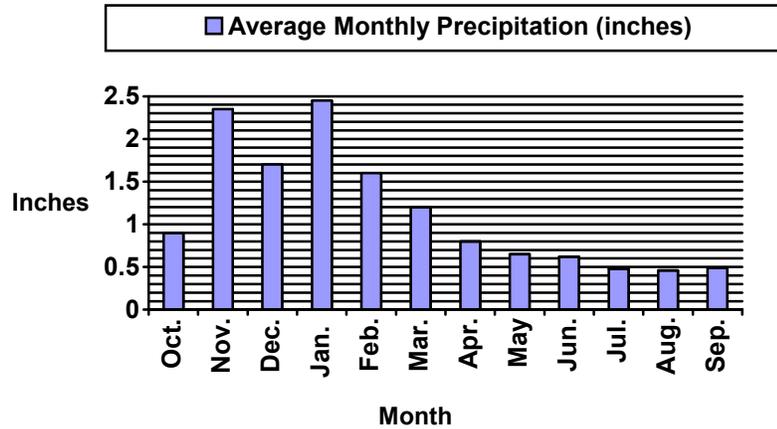
Figure 2: Average Annual Precipitation Pattern for the Ponderosa Pine/ Bitterbrush Woodland Ecoregion of the Upper Deschutes Subbasin

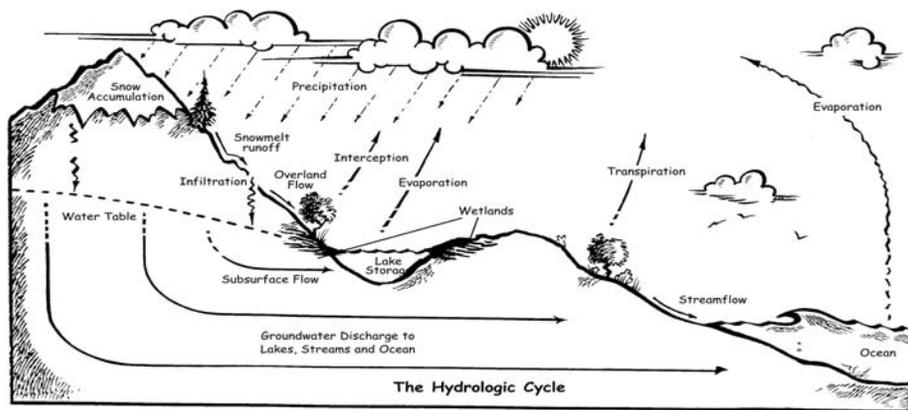
Figure 4: A Generalized Hydrologic Cycle

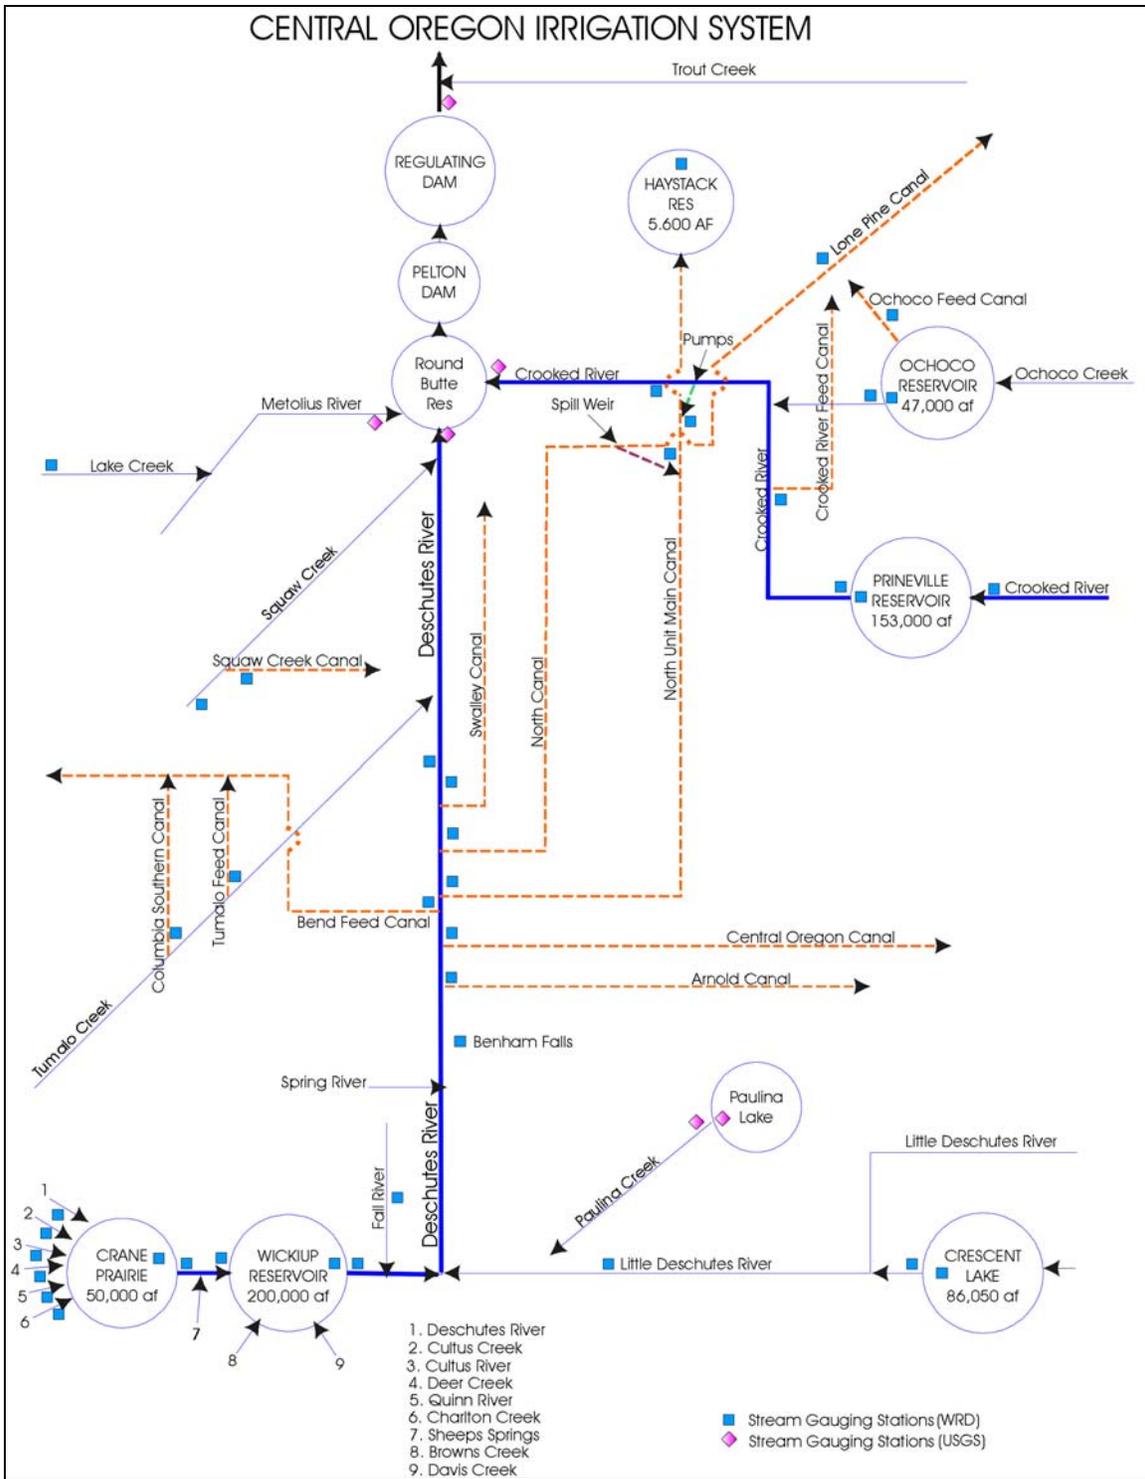
Figure 5: Central Oregon Irrigation System
 Source: OWRD 2001

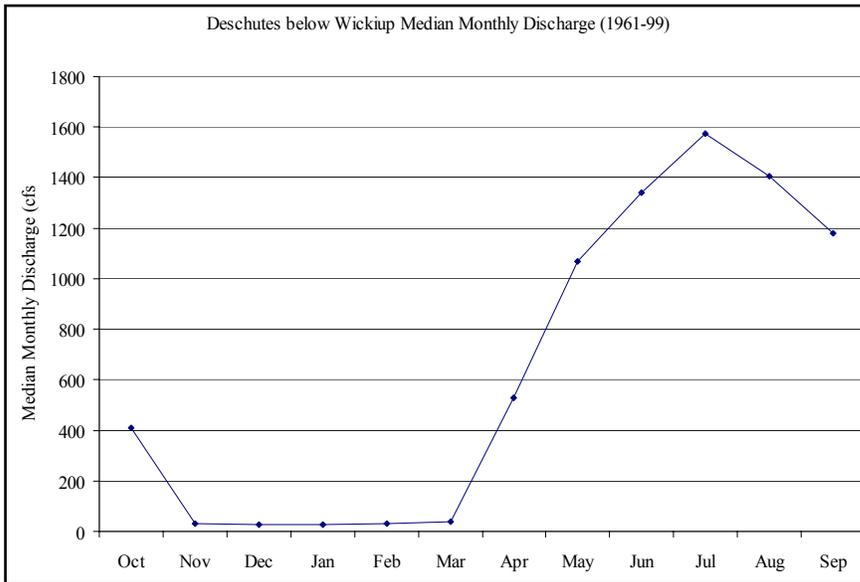
The median ratio of summer to winter flows from 1961 through 1999 is 1500 to 30 cfs below Wickiup reservoir (Figure 6) and roughly 30 to 600 cubic feet per second (cfs) below Bend (Figure 7). The swing between the maximum and minimum flows in these sections of the Deschutes is dramatic when compared to the natural stable hydrograph of the river. As currently managed, the minimum flows are substantially lower than they were historically. According to the Oregon Water Resources Department, “increasing flows in these reaches during low flow periods would benefit both the aesthetics and ecology of the river.” (OWRD 2001).

Figure 6: Median Monthly Discharge Below Wickiup Reservoir

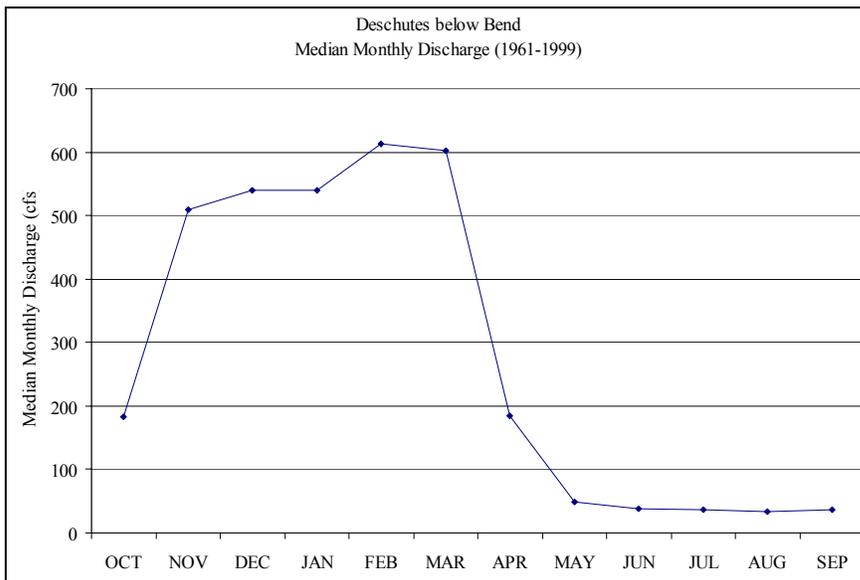
Figure 7: Median Monthly Discharge Below Bend

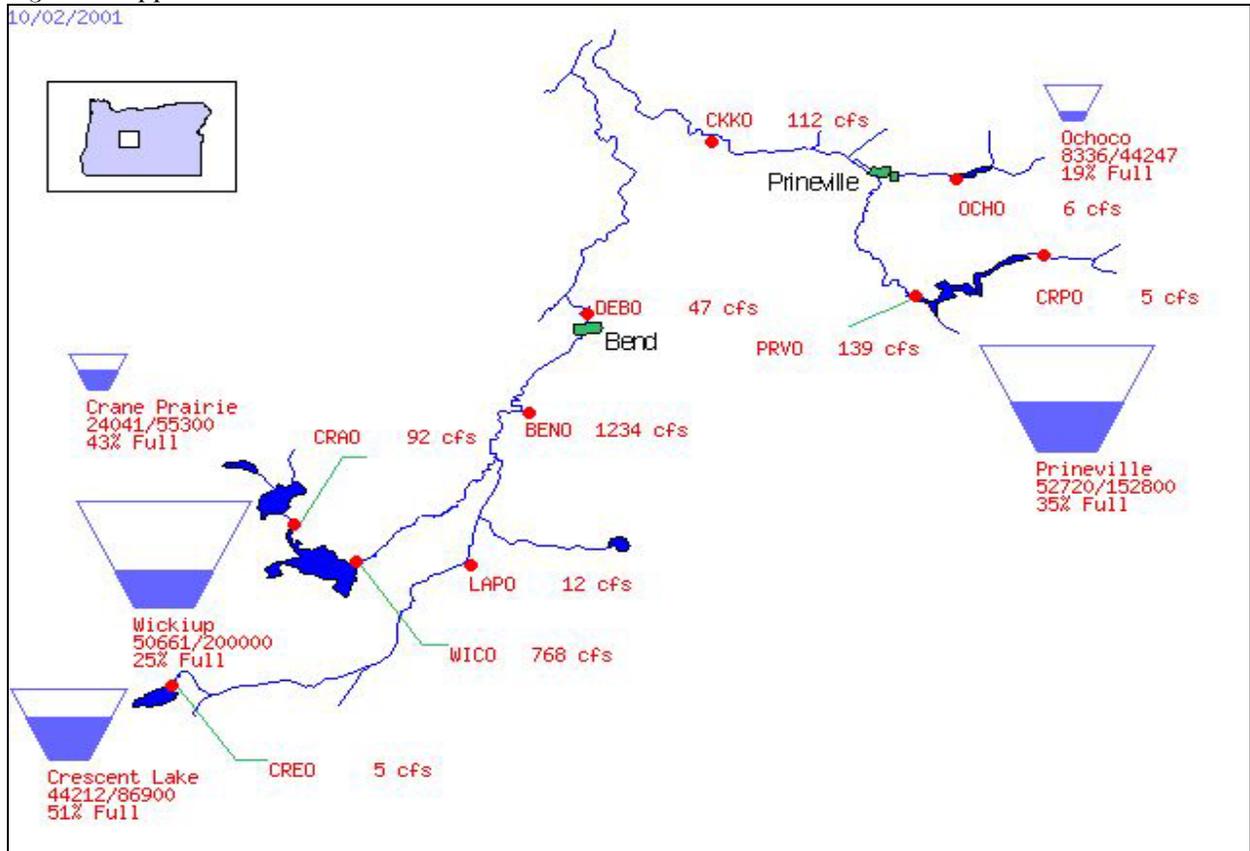
Figure 8 displays the primary reservoirs impacting the Upper Deschutes River flows. The depiction was created for a modeling report by the Oregon Water Resources Department at the end of irrigation season in 2001. In October of that year Crane Prairie held 24,041 acre-feet (43% of its capacity) and Wickiup held 50,661 acre-feet (25% of its capacity). Not shown in Figure 8 are the City of Bend's thirteen storage reservoirs for municipal water use.

Figure 8: Upper and Middle Deschutes Basin Reservoirs

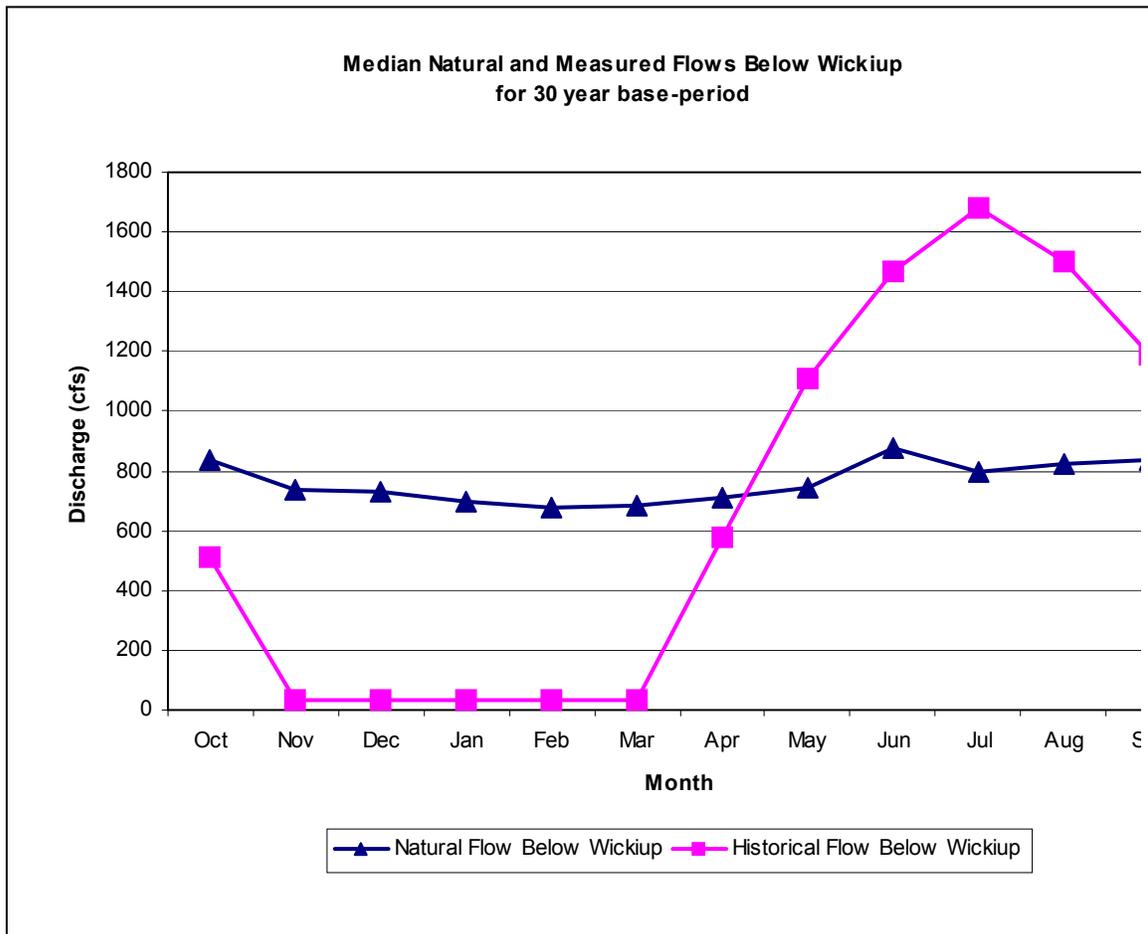
Figure 1: Median Natural and Regulated Flows Below Wickiup Reservoir (OWRD 2002)

Minimum Daily Flow (winter)	Maximum Daily Flow (summer)
Regulated Flow (1943-1987)	20 cfs	2280 cfs
Natural (unregulated) flow (1925-1941)	419 cfs	1400 cfs
Comparison between	95% decrease in flow under regulated	162% increase in flow under regulated

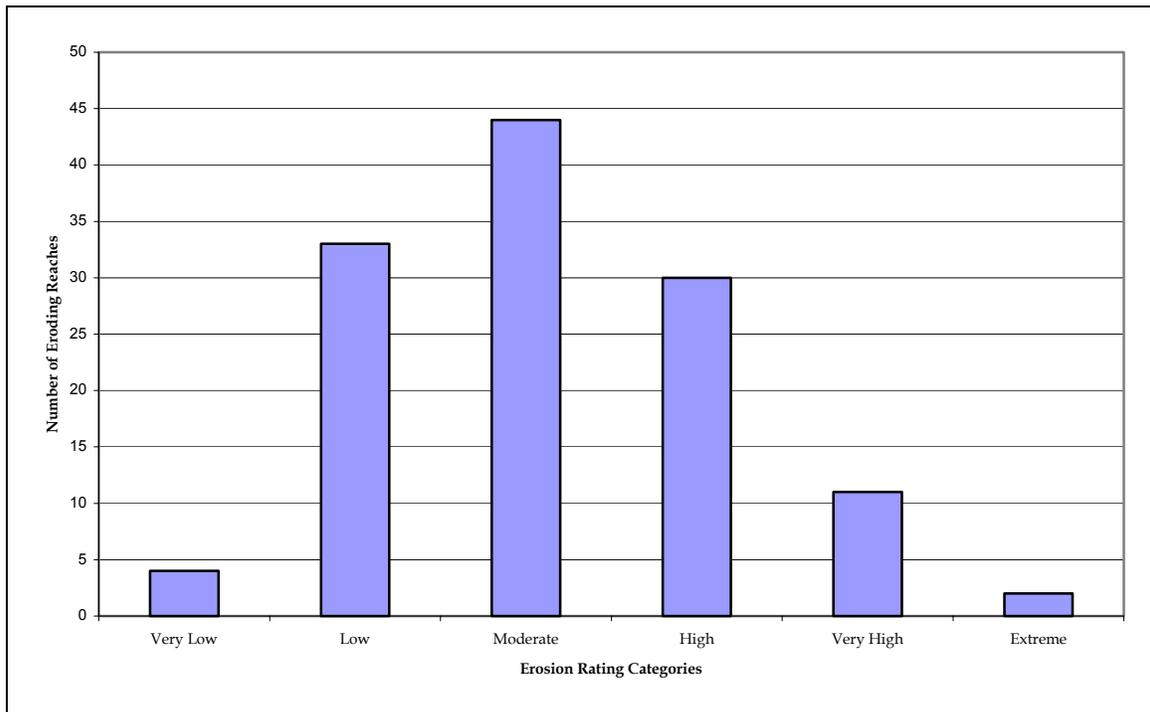
Figure 2: Stream bank Erosion Ratings for the Upper Deschutes River

The results indicate that 47 reaches on the Upper Deschutes are currently eroding at high, very high, or extreme rates. Analysis of the methodology for assessing the bank heights of stream sections has revealed that there may in fact be a greater number of high, very high, and extreme banks than the study indicates due to the fact that bank height and surface protection were both measured to the very top of the bank instead of to the top of the eroding portion of the bank. Therefore, it might appear that there is a greater percentage of surface cover protecting the bank from eroding than currently exists.

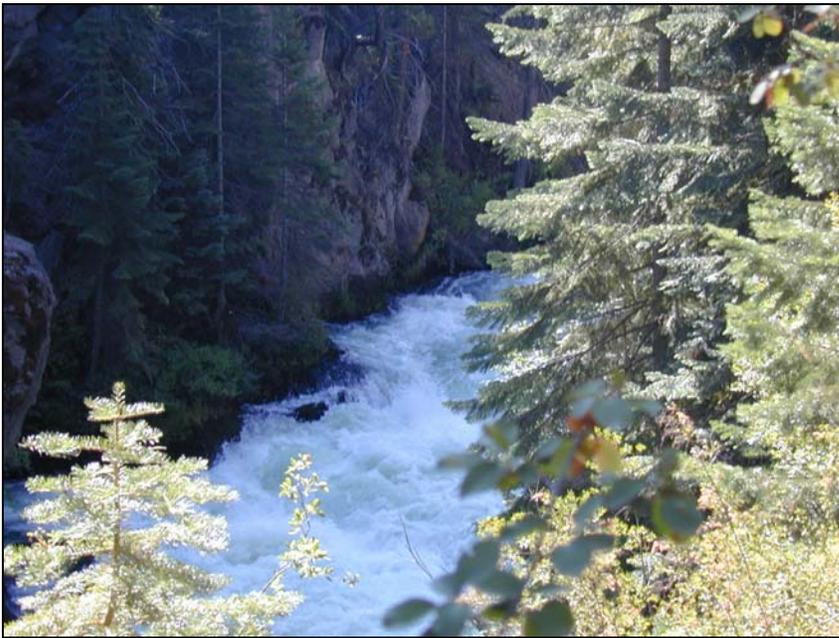
Photograph 1: Reach 104, Benham Falls

As mentioned in the introduction, some sections of the Upper Deschutes are naturally resistant to erosion due to the geology of the area. Taken from the overlook at Benham Falls, photograph 1 displays the bedrock that is remnant from the Lava Butte Flow from the eruption of Newberry Volcano. The lava rock remains and lines the channel at Benham Falls. Although the gradient and velocity are high in this reach, the erosion potential is very low.

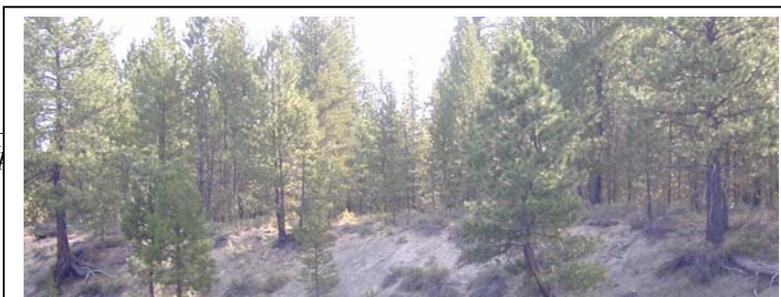
Photograph 2: Reach 51, La Pine State Park

Distinctly different from the banks at Benham Falls, the stream reach in photograph 2 consists of primarily silt and clay fine sediments. This reach is located at river mile 209 near La Pine State Park. The bank received a BEHI rating of moderate due to the combination of loose bank materials, moderate vegetation, and a 45 degree bank angle. The sedges and other herbaceous material at the water's edge combined with some surface protection from the pine roots to prevent a higher erosion rating.

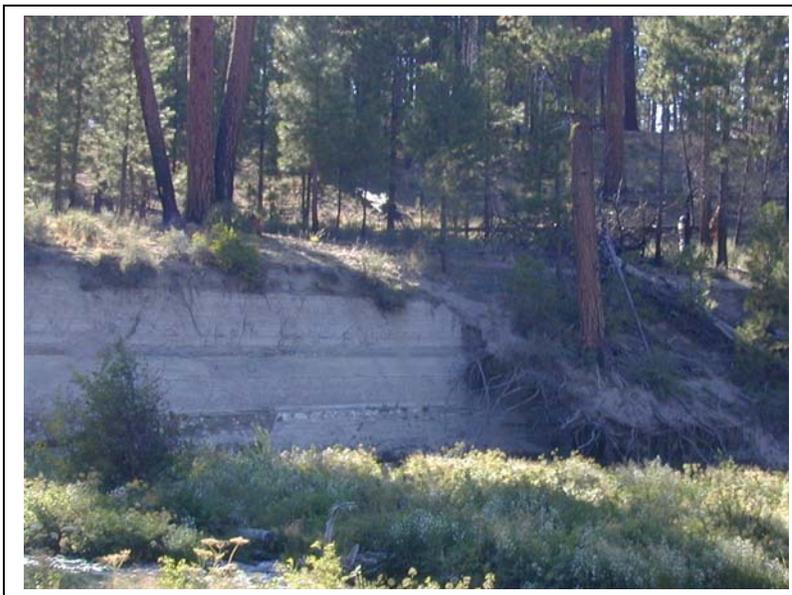
Photograph 3: Reach 30, Tetherow Log Jam

Taken just below river mile 213, photograph 3 presents a stream bank that received a BEHI rating of extreme. On this bank there is vegetation at the top portions of the bank but it is serving no protective service to the erosion or erodability of the bank at the water's edge.

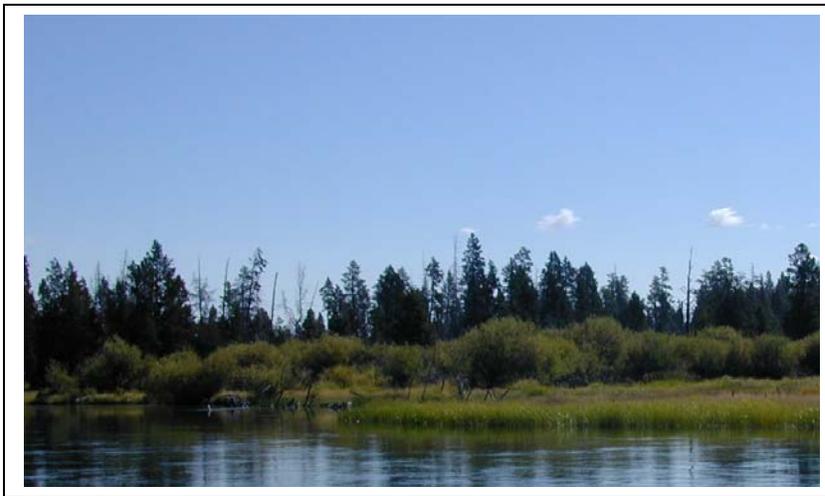
Photograph 4: Reach 62, Fall River Area

The relatively small number of banks receiving a very low BEHI rating is due to the fact that a large percentage of the banks that appeared to have no erosion problem were not included in the assessment. Reach 62 shown in photograph 4 is a bank that was assessed in order provide a representative sample of banks that, due to high levels of surface protection and low height, have very low or no erodability potential. Photograph 4 is representative of the majority of inside meander bends on the Upper Deschutes. As in the photo, the inside of meanders were typically deposition areas that had well established sedge meadow and willow vegetation.

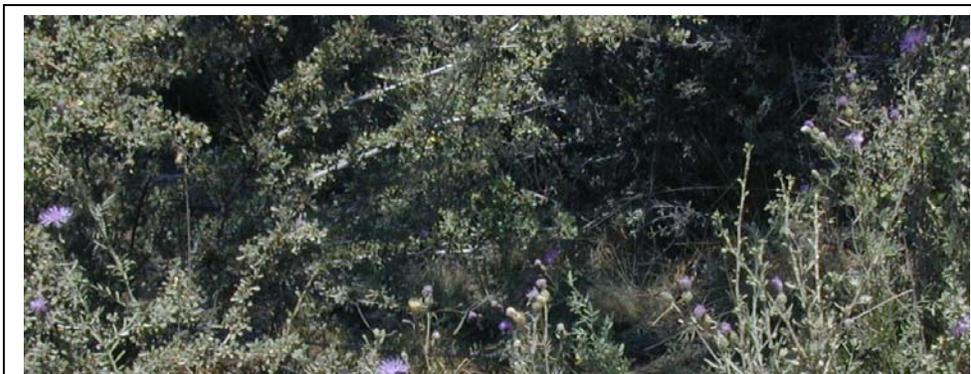
Photograph 5: Reach 108, ¼ mile downstream from Slough campground

Photograph 5 shows a substantial patch of knapweed located right on the river trail. This patch of knapweed is between the trail and the water's edge. As knapweed sends down a single deep taproot, the weed can exacerbate erosion but edging out other native riparian vegetation that would more effectively hold soil in place.

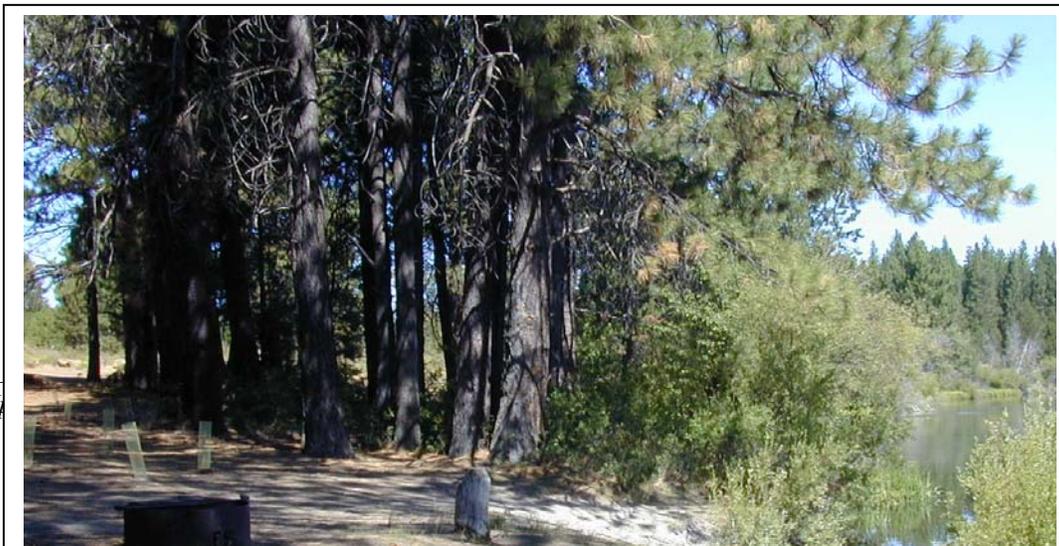
Photograph 6: Reach 107, Slough

Photograph 6 was taken at Slough campground near river mile 180. There is an overnight campground, a dirt road, and a boat launch located here and the river trail runs from Bend up through the campground. Although the campground receives high levels of use, the erosion is low. The low erosion is probably due to low bank heights and lower water velocity.
