DESCHUTES RIVER – BANK STABILIZATION PROJECTS ASSESSMENT

Prepared for:

River Design Group, Inc.
6029 SW 33rd Place
Portland, Oregon 97239

December 2005

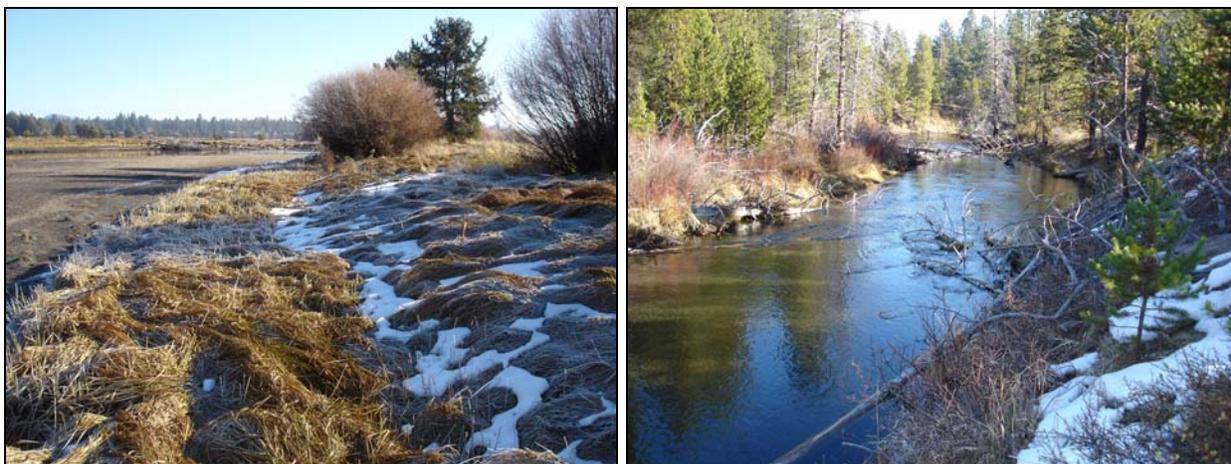
Figure 4-17. Example reference riparian conditions on the Upper Deschutes River near the Sunriver Marina (left) and on the Fall River (right). Both sites exhibit the transition from the near-channel sedges to the upland conifers. Basing revegetation prescriptions on these species set at appropriate elevations is important for long-term vegetation survival.

Vegetation conditions associated with projects was typically poor, especially when floodplain benches were not built adjacent to the treated bank. The large annual fluctuation in river stage creates a difficult situation for planting vegetation. Future projects should use adjacent floodplain areas as templates for determining appropriate elevations for planting sedges, willows, and upland vegetation. A predictable pattern was seen throughout the system whereby sedges inhabit the channel area near the high water stage; willows occupy an area about 0.5 ft to 1 ft above the sedge surface, and upland vegetation colonizes drier upland surfaces (Figure 4-17). Several of the projects either did not have a revegetation component or did not use reference vegetation conditions to guide planting.

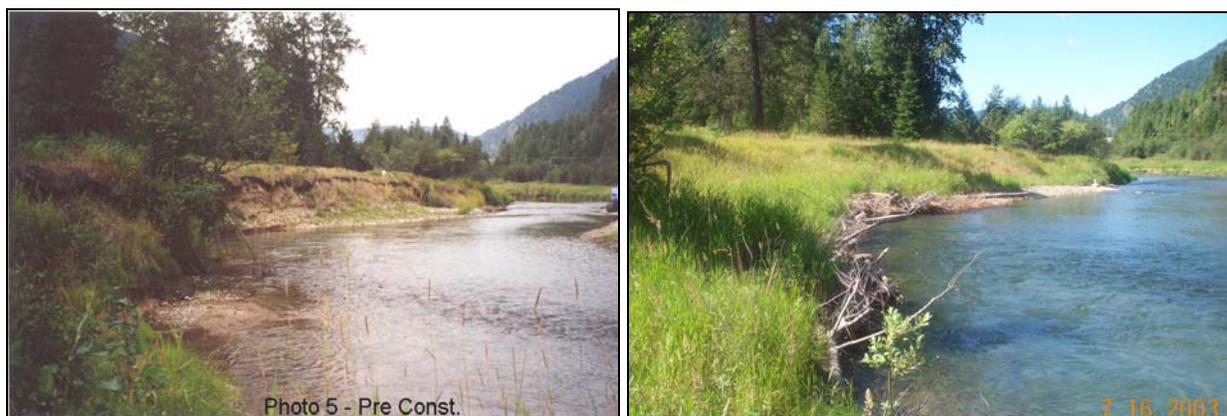
Figure 6-1. An example of a floodplain bench constructed on a low gradient sinuous river in northwestern Montana. The preconstruction condition was dominated by a high eroding terrace (left). The terrace was sloped and a floodplain bench was built at the toe of the terrace (right). The post-construction photo was taken 2 years after construction.

Floodplain benches lower the bank height relative to the water surface elevation, increasing riparian vegetation survival and productivity (Figure 6-1). Incorporating woody debris structures in combination with a comprehensive revegetation plan improves bank stability and aquatic habitat diversity.

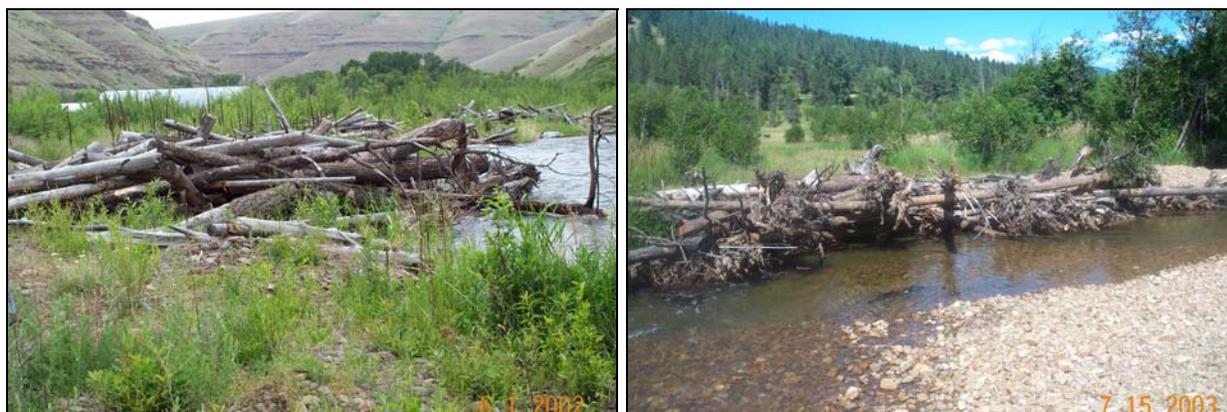
Figure 6-2. Two examples of woody debris jams in eastern Washington (left) and western Montana (right). Structures are anchored to reduce material loss.

Woody debris structures jams are designed to deflect the stream flow away from the bank, promote sediment deposition along the bank margin, and provide aquatic habitat (Figure 6-2). Structure spacing is dependent on structure size and site characteristics. Material should be collected near the site to minimize transport costs and to maintain the natural aesthetics of the structures. Recommended materials include large woody debris, small woody debris, and large

rock for anchoring the woody material in the bank. Large rock should be buried below grade to improve structure aesthetics. Anchoring cables may be necessary to augment structure stability.
